## Environmental Appraisal of Pushkar Lake Catchment Area with Special Reference to Siltation- An Investigation

### ABSTRACT

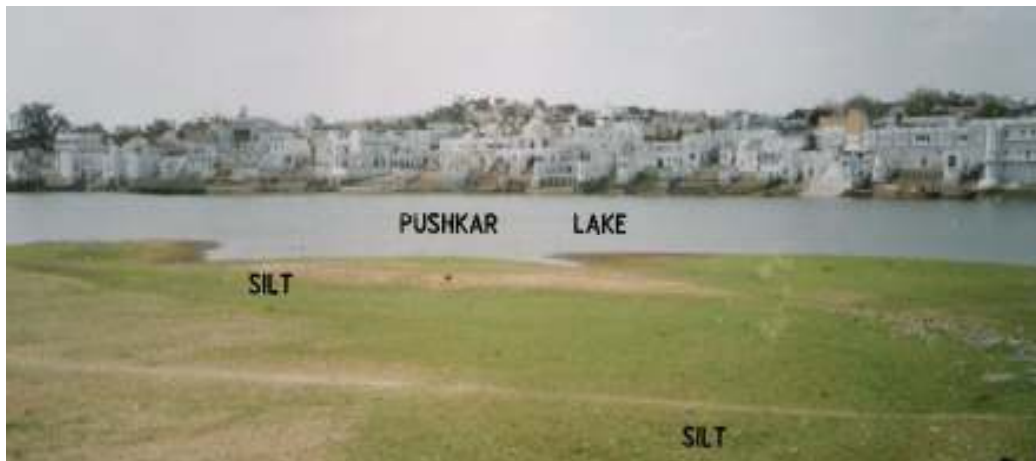
*Photo 1- Pushkar Lake with Silt*

Pushkar Lake is situated at a distance of 11 km. to the west of Ajmer city. The terrain of Pushkar and its surrounding is of complex nature. To the west and south west of lake at a distance of about 1.5 km. lies the extended part of Thar desert with Semi Arid conditions. Aravalli hills locally known far *Nag Pahar* is in the east of lake, and have deciduous forest cover, These hills are insufficient to check silt flow. Presently, the Lake is facing a severe problem of siltation by transportation and deposition of Aeolian sand, through its streams in the rainy season and through winds in summer season. (Photo 1)

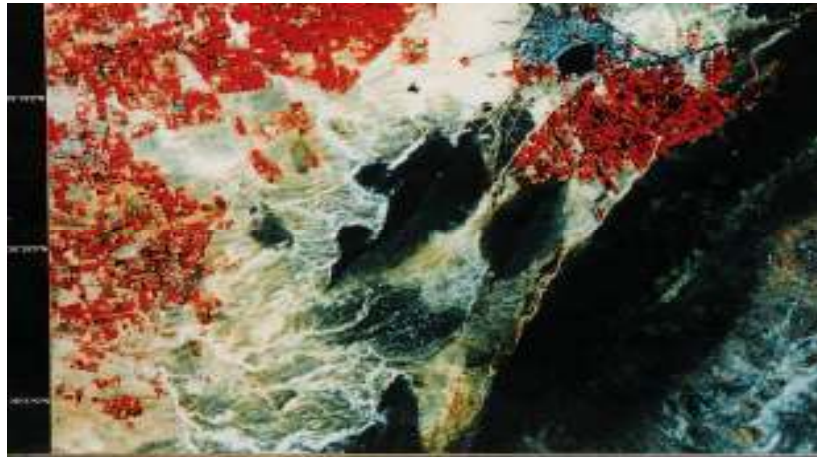
*Fig. 1 Satellite Image of Pushkar (IRS 1D Liss III Feb., 2004)*

The study area is located in between 26°26' to 26°31' north latitude and 74°26' to 74°36' east longitude comprising of 6330 hectares of Pushkar Lake and its siltation zone; out of which 4030 hectares is wind-eroded area and 385 hectares is of water-eroded area. (Fig. 1)

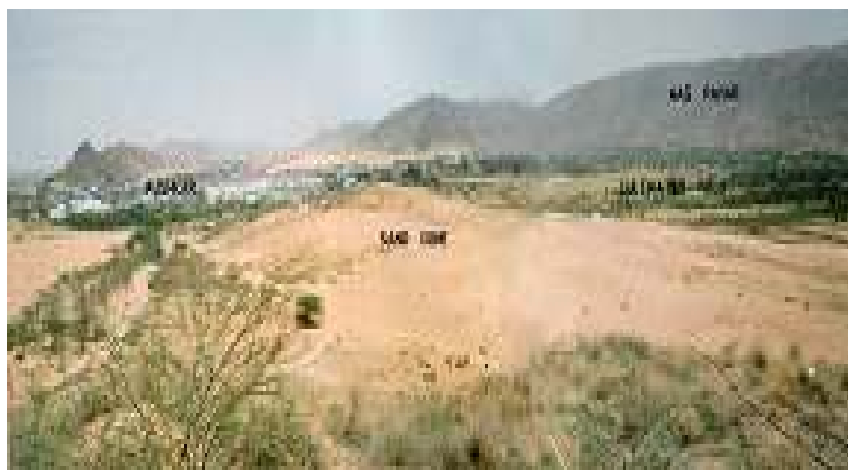
*Photo 2 a Pushkar and surrounding*

The average annual rainfall is 520 mm. (Ajmer station) and 90% of which is being received in between months of June and September. The area which is part of Aravalli ranges with undulating hill and sand deposition on older alluvium, surrounding hills and valleys have moderate to poor vegetative cover. (Photo 2 a, 2 b)

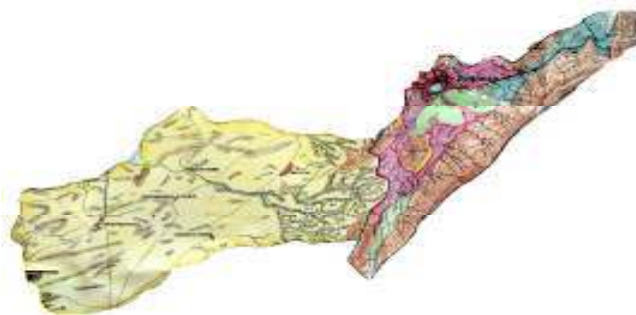
Fig. 2 Pushkar Lake Source of Siltation

1. **Sand transported by wind:** Sand dunes are prevalent in the south western part of the catchment, extending from the areas nearby villages namely Bhagwanpura, Koti, Bachan Singhji ki Dhani, Pabuji ki Dhani, Hajari ki Dhani and Motisar to the western banks of *Savitri* feeder and *Kharikheri* feeder or *Gori Nadi*, drawing their water from the southern part of the catchment area of the lake. Fresh sand from erosion affected area is carried by blowing wind and is deposited on the partially stabilized existing sand dunes of the western banks of streams. This process of wind erosion is more active during the period of February to July. (Fig. 2)

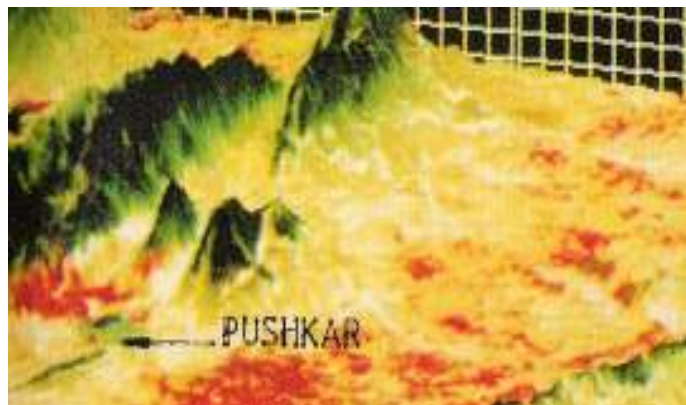
*Fig. 4 - Digital Terrain Model*

The DTM output show high *Nag Pahar* toward north-east which forms the ridge line of the lakes catchment. Sand carried by south-western wind is obstructed by the hillocks and carried by runoff from upper reaches. This sand gets deposited at the entrance of the lake and stops further inflow. (Fig. 4)

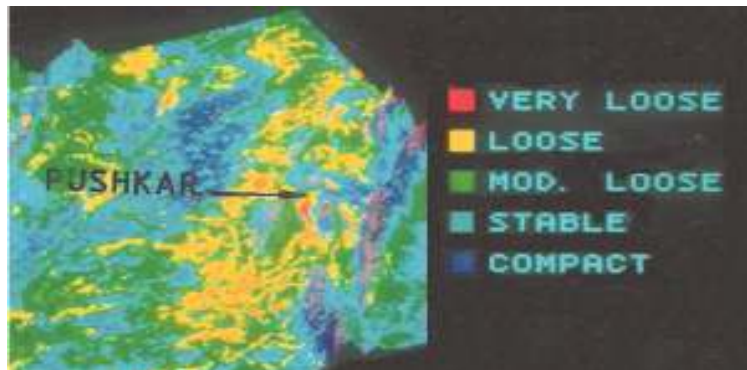
Fig. 5 – Soil Brightness index

Soil Brightness Index of the study area was generated by linear combination of bands using appropriate coefficients. Density sliced soil brightness index image resulted into four categories viz. very loose sand, loose, moderate loose, stable and compact, showing their spatial distribution of various hills slopes. (Fig. 5)
